**Flood Control Project Maintenance
Levee Inspections****LMA District Cover Sheet****Spring 2016 Levee Inspection Results****Sutter Maintenance Yard Maintenance Area 0003**

Levee Inspection Report By Mile - Spring 2016

Sutter Maintenance Yard Maintenance Area 0003

Waterway	Bank	Unit Miles	Inspection Start/End	Inspector
Unit No. 01 Feather River	Right	5.11	03/24/2016 03/30/2016	Sterling York

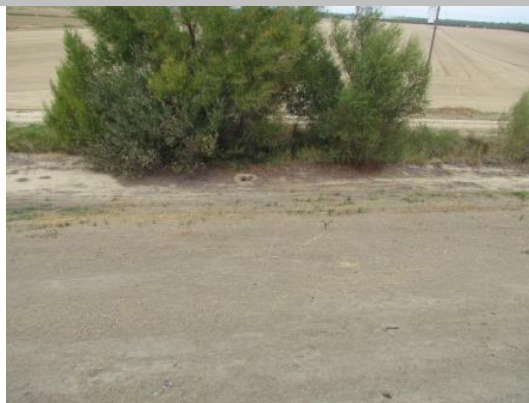
Photo 2 of 2 : SP_2016_MA0003_195_140_20160307_00012.jpg

This is another photo of the rodent hole to show its relationship to the levee toe, toe road, and drainage ditch. Fall 2014.

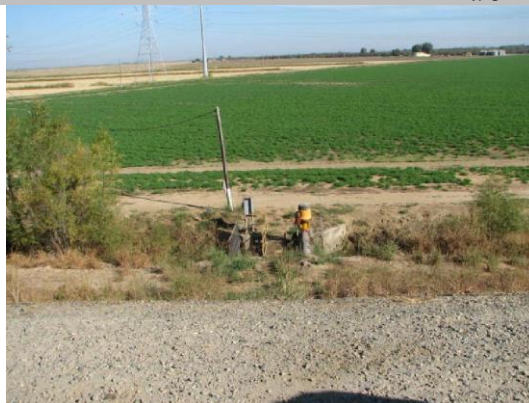
Photo 1 of 2 : UCIP_SP_2016_48415_64654.jpg

Comment Code					
Inspector Comment					
FS_ID:48415 DS_ID:17091 EP_NO: 13624 Repair Type: Urgent Crossing Status: Found UCIP Comments: 4/18/2016 No repairs have been made to the pipe yet.5/12/2015 Water level high in WS ditch so could not see WS end of crossing. Do not believe that repairs have been made yet.11/17/2014 Same as last inspection.5/14/2014 Pipe section that was suspected of leaking was dug up and deemed to be in good condition. No signs of leaks were found.10/30/2013 Same as last inspection.5/21/2013 SBFCA project recommends replacing in accordance with title 23. Hole in slope along outside of standpipe thats about 1 foot deep with moisture in the bottom. Dirt inside standpipe around siphon breaker also wet indicating there may be a leak. Need to investigate source or moisture. FIELD_STRUCT_DESC: 20-inch steel drainage pipe through the levee 3 feet below the crown. Siphon breaker on the waterside (WS) shoulder. Open on WS end. Pump in ditch on landside (LS). (Permit No. 13624-1983, Danna and Danna, Inc.) [Additional Reference(s): DWR Levee Log, 2005]. FS Date: 4/22/2016 12:55:00 PM

Pump on concrete headwall at LS toe.

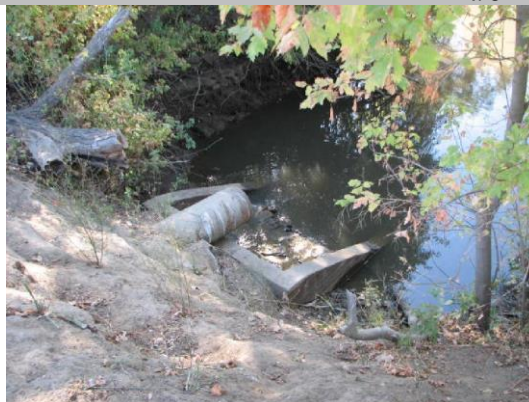
Photo 2 of 2 : UCIP_SP_2016_48415_64653.jpg

Pipe at outlet on WS toe

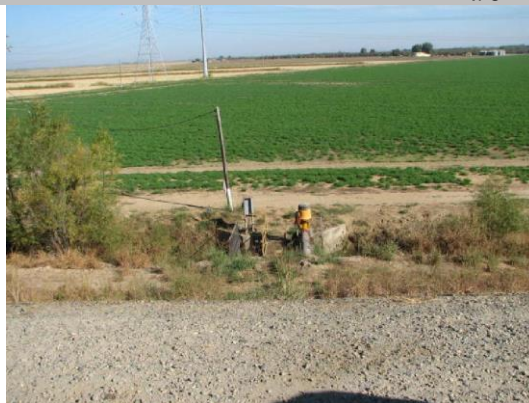
Photo 1 of 2 : UCIP_SP_2016_48094_64649.jpg

FS_ID:48094
DS_ID:17092
EP_NO: N/A
Repair Type: Urgent
Crossing Status: Found
UCIP Comments: 4/18/2016 No repairs have been made to the pipe yet.5/12/2015 Water level high in WS ditch so could not see WS end of crossing. Do not believe that repairs have been made yet.11/17/2014 Same as last inspection.5/14/2014 Same as last inspection.10/30/2013 Same as last inspection.5/21/2013 SBFCA project recommends replacing in accordance with title 23. High water levels in WS ditch have pipe ends underwater but repairs have not yet been completed but are planned for when water levels drop.10/10/2012 Flap gates not visible on waterward headwall and it appears as though they have been replaced by sandbags. Slide gates on LS appear to be closed yet water leaks excessively from the WS at the sandbagged headwall.
FIELD_STRUCT_DESC: 1 of 2. 18-inch drainage pipe through the levee, 32.0 feet below the crown. Flap gate on the waterside (WS) end. Slide gate on the landside (LS) end at concrete headwall.

Concrete headwall with walkway and slide gates at LS toe.

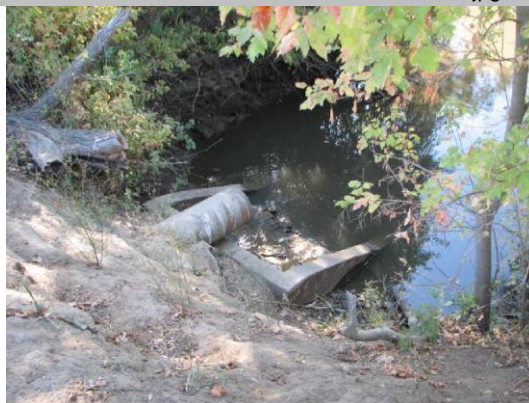
Photo 2 of 2 : UCIP_SP_2016_48094_64648.jpg

Concrete U shaped headwall on WS toe filled in with Sandbags. 16-inch pipe shown over top of headwall.

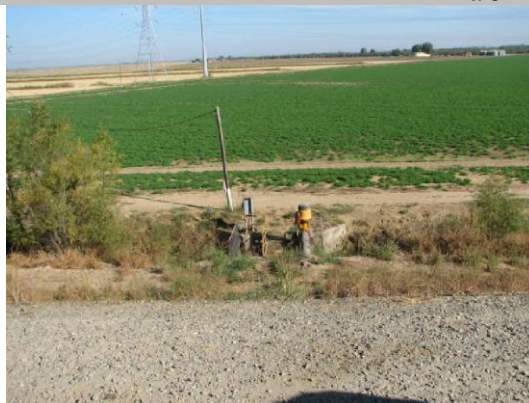
Photo 1 of 2 : UCIP_SP_2016_48414_64662.jpg

FS_ID:48414
DS_ID:17136
EP_NO: N/A
Repair Type: Urgent
Crossing Status: Found
UCIP Comments: 4/18/2016 No repairs have been made to the pipe yet.5/12/2015 Watelevel high in WS ditch so could not see WS end of crossing. Do not believe that repairs have been made yet.11/17/2014 Same as last inspection.5/14/2014 Same as last inspection.10/30/2013 Same as last inspection.5/21/2013 SBFCA project recommends replacing in accordance with title 23. High water levels in WS ditch have pipe ends underwater but repairs have not yet been completed but are planned for when water levels drop.10/10/2012 Flap gates not visible on waterward headwall and it appears as though they have been replaced by sandbags. Slide gates on LS appear to be closed yet water leaks excessively from the WS at the sandbagged headwall.
FIELD_STRUCT_DESC: 2 of 2. 18-inch pipe through the levee, 32.0 feet below the crown. Flap gate on the waterside (WS) end. Slide gate on the landside (LS) end at concrete headwall. Concrete "U" headwall at the WS toe. [Additional Reference(s): DWR Levee Log, 2005. USACE Sacramento O&M Manual 143, August 1955 (Station 982+00)].

Concrete headwall, slidegates, and metal walkway on LS toe.

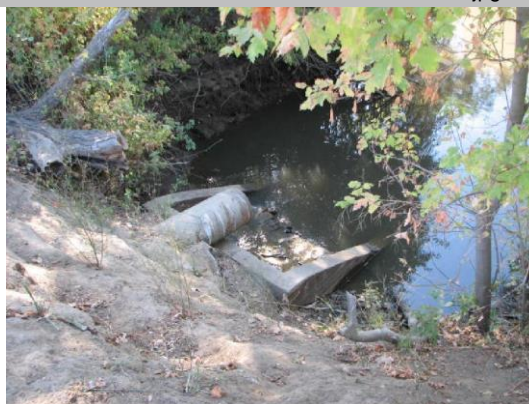
Photo 2 of 2 : UCIP_SP_2016_48414_64661.jpg

Concrete U shaped headwall on WS toe filled with sandbags.

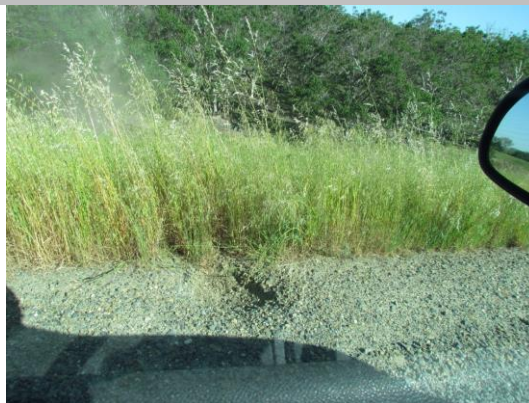
Photo 1 of 1 : SP_2016_MA0003_195_13_20160307_00006.jpg

LM Start	1.51	Rating **	M	Issue No.	13
LM End	1.51	Issue Type +	Ma	Location *	CR
Category	Earthen Levee			GPS Latitude/Longitude	
				Start	End
Item	Crown Surface / Depressions / Rutting			38.904680 °	38.904680 °
				-121.594229 °	-121.594229 °
DWR ID	DWR_MA0003_01_s_2015_13				
Comment Code					
C2 : Repair depressions or ruts in the crown or slope.					
Inspector Comment

Photo of a depression in the crown, taken looking at the landside.

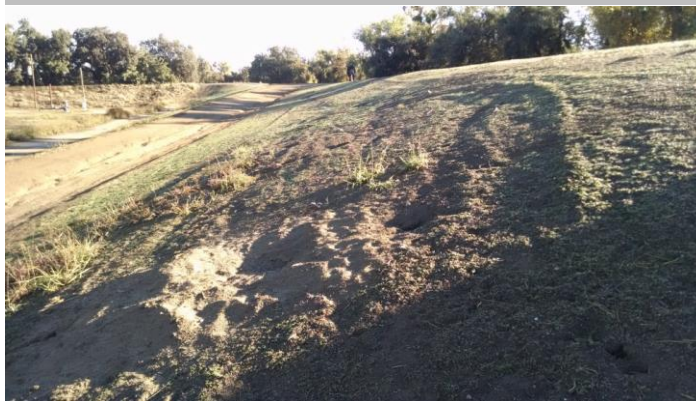
Photo 1 of 1 : SP_2016_MA0003_195_14_20160307_00007.jpg

LM Start	1.77	Rating **	M	Issue No.	14
LM End	1.77	Issue Type +	Ma	Location *	LS
Category	Earthen Levee			GPS Latitude/Longitude	
				Start	End
Item	Animal Control			38.907025 °	38.907025 °
				-121.590375 °	-121.590375 °
DWR ID	DWR_MA0003_01_s_2015_14				
Comment Code					
A3 : No rodents visible, but rodent burrows visible; need to backfill and compact or grout burrows.					
Inspector Comment

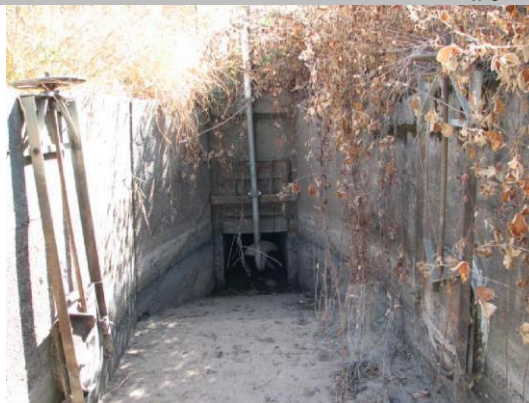
Photo 1 of 2 : UCIP_SP_2016_48417_64668.jpg

FS_ID:48417
DS_ID:17088
EP_NO: 3284
Repair Type: Non-Urgent
Crossing Status: Found
UCIP Comments: 4/18/2016 WS vault is being overgrown with blackberries. They should be sprayed and cleared back. No other problems were noticeable with this crossing.5/12/2015 Only the right flapgate appeared to be abandoned. The left and middle flap gates were flowing water during the last inspection.11/17/2014 Same as last inspection.5/14/2014 Same as last inspection.10/30/2013 Same as last inspection.5/21/2013 Pumping plant was running and filling concrete vault on WS toe through the left flap gate and then flowing through levee pipe and filling irrigation ditch on LS. Left and middle flap gates appear to be connected to pumps and right gate appears abandoned. Recommend contacting owner to get more details.10/10/2012 Pumping plant has been disconnected from levee. Need to determine if abandonment is appropriate or if this is now a gravity drain with flap gate.

32X32 box culvert on LS toe in Concrete U shaped channel with slide gate.

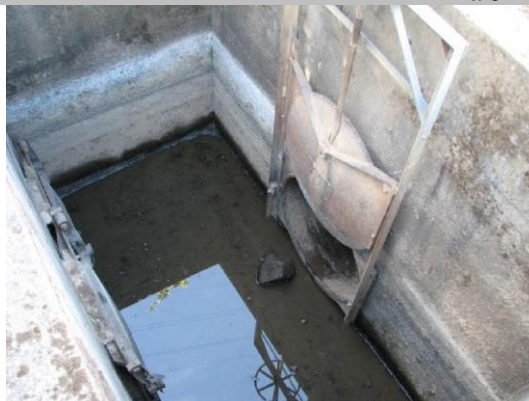
Photo 2 of 2 : UCIP_SP_2016_48417_64667.jpg

FS_ID:48417
DS_ID:17088
EP_NO: 3284
Repair Type: Non-Urgent
Crossing Status: Found
UCIP Comments: 4/18/2016 WS vault is being overgrown with blackberries. They should be sprayed and cleared back. No other problems were noticeable with this crossing.5/12/2015 Only the right flapgate appeared to be abandoned. The left and middle flap gates were flowing water during the last inspection.11/17/2014 Same as last inspection.5/14/2014 Same as last inspection.10/30/2013 Same as last inspection.5/21/2013 Pumping plant was running and filling concrete vault on WS toe through the left flap gate and then flowing through levee pipe and filling irrigation ditch on LS. Left and middle flap gates appear to be connected to pumps and right gate appears abandoned. Recommend contacting owner to get more details.10/10/2012 Pumping plant has been disconnected from levee. Need to determine if abandonment is appropriate or if this is now a gravity drain with flap gate.

8-foot X 14-foot concrete box on WS toe with slide gate and 3 abandoned flap gates.

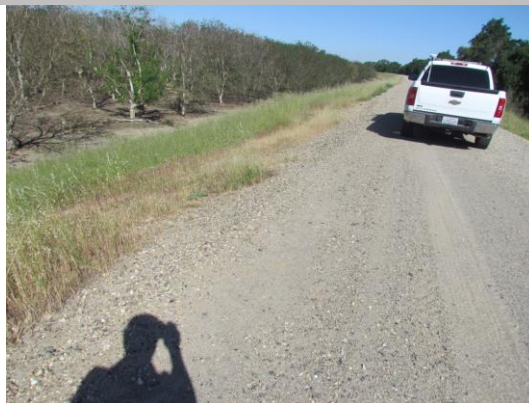
Photo 1 of 1 : SP_2016_MA0003_195_20_20160307_00010.jpg

LM Start	3.20	Rating **	M	Issue No.	20
LM End	3.20	Issue Type +	Ma	Location *	LS
Category	Earthen Levee			GPS Latitude/Longitude	
				Start	End
Item	Slope Stability			38.925909 °	38.925909 °
				-121.585401 °	-121.585401 °
DWR ID	DWR_MA0003_01_s_2015_20				
Comment Code					
S1 : Repair slope instability.					
Inspector Comment

Photo of slope on the landside facing upstream, areas with little vegetation appear to have eroded leaving the crown smaller.

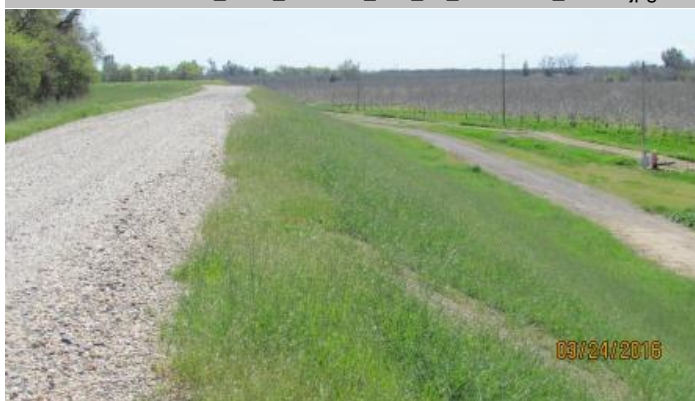
Photo 1 of 1 : SP_2016_MA0003_195_12_20160404_00028.jpg

LM Start	3.75	Rating **	M	Issue No.	12
LM End	4.47	Issue Type +	Ma	Location *	LS
Category	Earthen Levee			GPS Latitude/Longitude	
				Start	End
Item	Vegetation			38.932157 °	38.942033 °
				-121.591031 °	-121.587681 °
DWR ID	DWR_MA0003_01_s_2016_12				
Comment Code					
V1 : Control annual grass and weeds on the levee slopes and easements.					
Inspector Comment

Vegetation on the landside looking downstream.

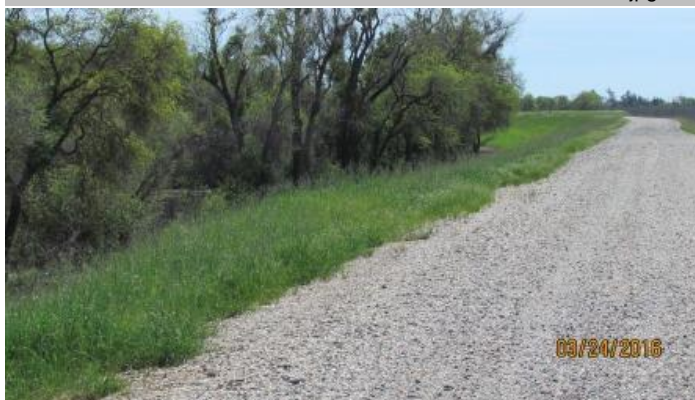
Photo 1 of 1 : SP_2016_MA0003_195_17_20160404_00027.jpg

LM Start	3.75	Rating **	M	Issue No.	17
LM End	4.47	Issue Type +	Ma	Location *	WS
Category	Earthen Levee			GPS Latitude/Longitude	
				Start	End
Item	Vegetation			38.932157 °	38.942039 °
				-121.591031 °	-121.587680 °
DWR ID	DWR_MA0003_01_s_2016_17				
Comment Code					
V1 : Control annual grass and weeds on the levee slopes and easements.					
Inspector Comment

Vegetation on waterside looking downstream.

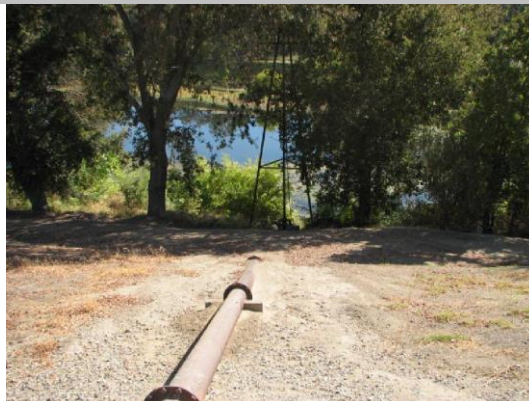
Photo 1 of 2 : UCIP_SP_2016_48421_64672.jpg

FS_ID:48421
DS_ID:17087
EP_NO: 1730
Repair Type: Non-Urgent
Crossing Status: Found
UCIP Comments: 4/18/2016 Big depression on LS toe along the pipe alignment. 5/12/2015 Crossing appears to be in good condition. No noticeable issues to report. 11/17/2014 Same as last inspection. 5/14/2014 Same as last inspection. 10/30/2013 Same as last inspection. 5/21/2013 SBFCA project recommends replacing in accordance with title 23. Same as last inspection.
FIELD_STRUCT_DESC: 12-inch pipe through the levee, 4.5 feet below the crown. Gate valve and pump located on the waterside (WS). 24-inch concrete standpipe located on the landside (LS) toe has been degraded to ground elevation and filled in with soil. Pipe remains intact. Steel tower over pump on is located on the WS. (Permit No. 1730, 1959-Robert L. Crandall). [Additional Reference(s): DWR Levee Log, 2005].
FS Date: 4/22/2016 1:02:00 PM

Pipe, pump, and tower on WS slope/toe.

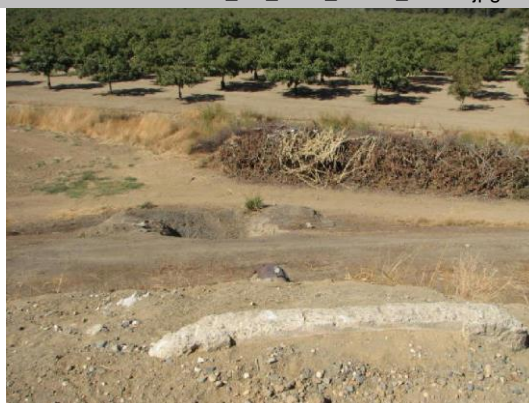
Photo 2 of 2 : UCIP_SP_2016_48421_64671.jpg

Pipe at LS shoulder showing exposed concrete cutoff wall.

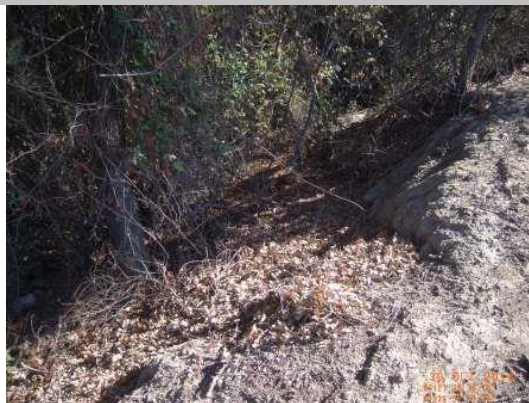
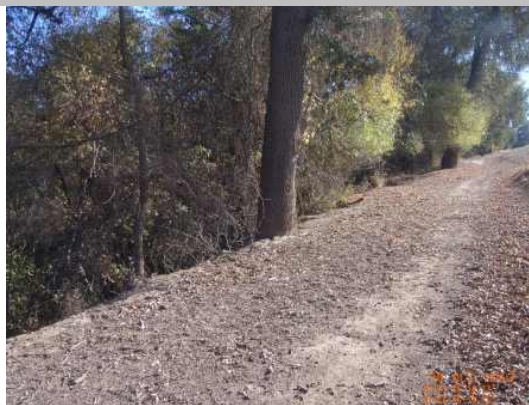
LM Start	4.15	Rating **	M	Issue No.	1
LM End	4.18	Issue Type +	Ma	Location *	WS
Category	Supplemental			GPS Latitude/Longitude	
				Start	End
Item	2015 USACE Erosion Survey, DRAFT			38.937451 °	38.937937 °
				-121.588512 °	-121.588471 °
DWR ID	DWR_MA0003_01_s_2016_1				
Comment Code					
Inspector Comment					
2013 - Minor toe scour causing gradual erosion of bank slope. Site is within ecological reserve. 2015: Last observed in 2013. [2015 Site ID: FHR_12-3_R]

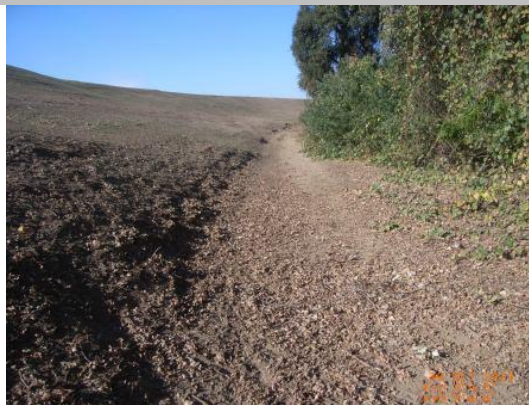
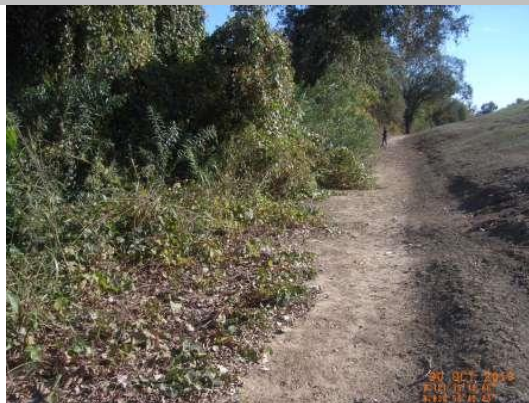
LM Start	4.71	Rating **	M	Issue No.	2
LM End	4.76	Issue Type +	Ma	Location *	WS
Category	Supplemental			GPS Latitude/Longitude	
				Start	End
Item	2015 USACE Erosion Survey, DRAFT			38.945188 °	38.945958 °
				-121.586096 °	-121.586394 °
DWR ID	DWR_MA0003_01_s_2016_2				
Comment Code					
Inspector Comment					
2013 - Minor toe scour causing gradual erosion into the bank slope.					
2015: Last observed in 2013. [2015 Site ID: FHR_12-8_R]
